**RESOLUTION TO ADVERTISE FOR BID TO REPLACE  
BOWSER STREET PUMP STATION**

**BOWSER ROAD PUMP STATION**

Monticello Wastewater Treatment Plant-West  
NPDES Permit Number AR0021822

**Project Number 22-5782**

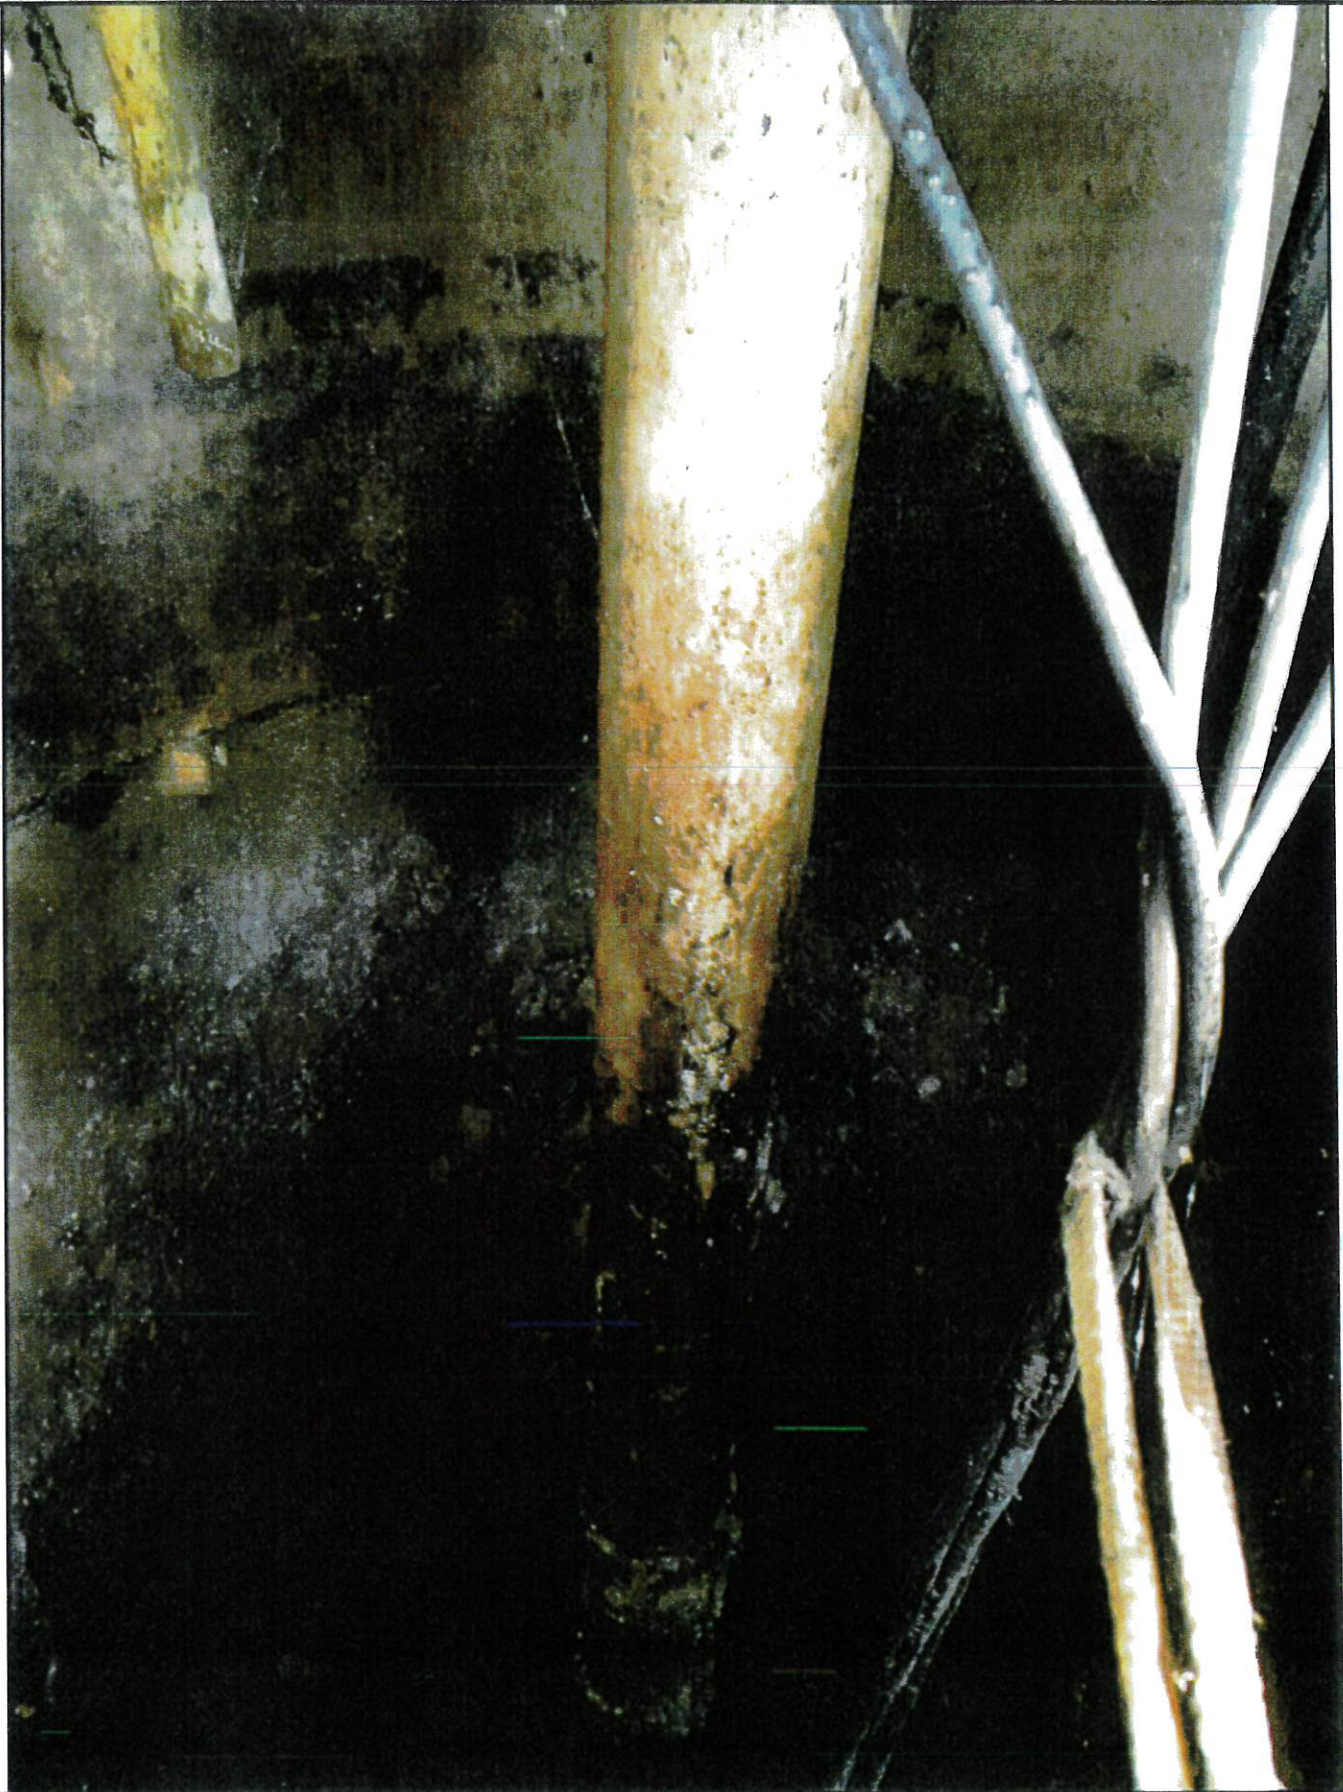
**FIG 4**

The wet well is approximately a 5-foot inside diameter circular well that has floats indicating pump off and on positions. The bottom of the wet well is sloped. Figures 2 to 4 shows lift station and wet well.

INSIDE OF THE WET WELL FROM A DIFFERENT ANGLE

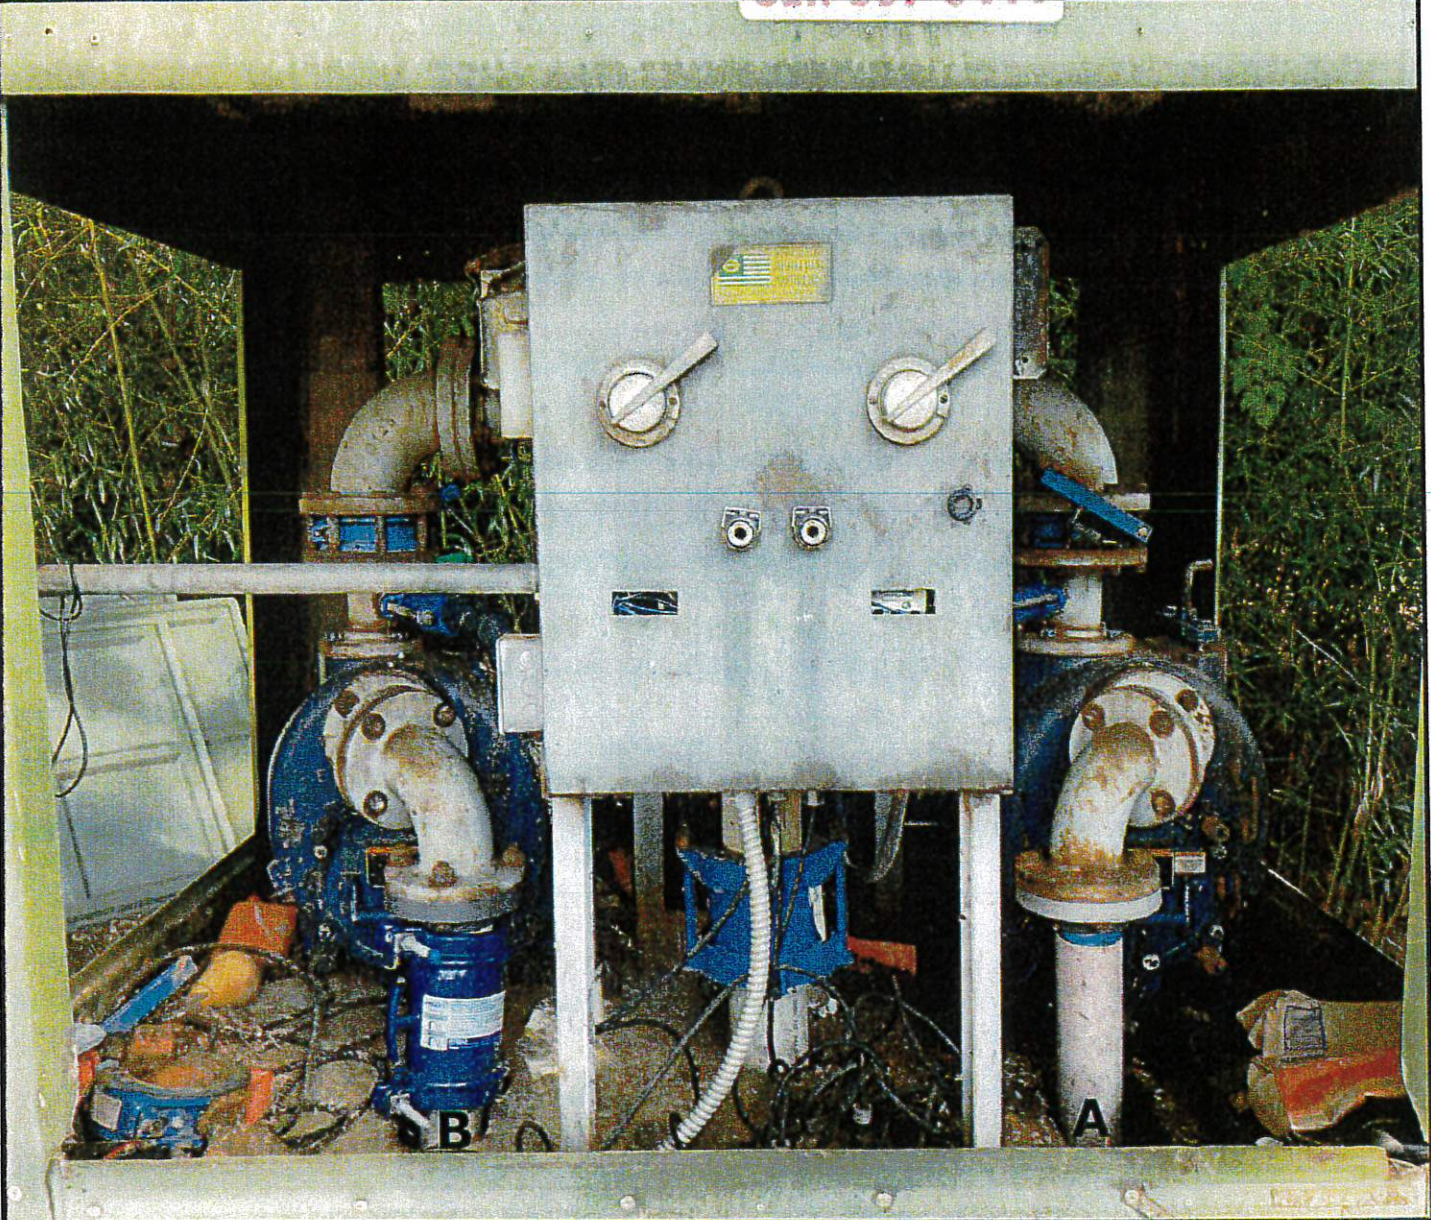
**FIG 2**

The two horizontal self-priming centrifugal pumps are Super T Series manufactured by Gorman-Rupp. As shown in Figure 2 the pumps are numbered pump “A” and pump “B” with the same model no T3A3S-B. Pump “A” is at the right-hand and pump “B” is at the left-hand of Figure 2. The serial number for pump “A” is 1435305, and the serial number for pump “B” is 1617167. The size of the pump is 3” by 3” and each pump delivers 75 gpm at total dynamic head (TDH) of 30 feet.

THE TWO PUMPS IN  
THE LIFT STATION.

An attempt was also made to ascertain the possibility of pump "B" to deliver raw wastewater to the force main. Pump B was running but was not priming, therefore, it was unable to deliver wastewater to the force main. No vibrations or unusual noise was noted, though it was not measured.

The check valve of the pump “A” functioned properly when the pump was started, and delivered wastewater to the force main without any priming issues. However, the check valve of pump “B” malfunctioned when the pump was started. The pump was unable to deliver raw wastewater to the force main because it was not priming. It is very likely that the check valve might had also contributed to the non-priming of the pump; albeit, excessive impeller clearance might had also played some role.

The plug valve was literally not turning regardless of the amount of force applied. The apparent cause is a lack of maintenance. This condition of the plug valve raises a question on the reliability of the lift station. The plug valve ties the two pumps together, which means neither of the pumps can be isolated for any form of maintenance or emergency scenarios.

Because the check valve of pump "B" was not in good working condition and the plug valve that connects the two pumps cannot turn, the pumps would be replaced. Replacement of the pumps can take place in several ways:

- The pumps should be replaced with a 3-inch pump run by 5-hp motors
- The 5-hp motors can support rotational speeds from 1330 to 1500 rpm. This signifies that the speed can be adjusted in the future should the need arise.

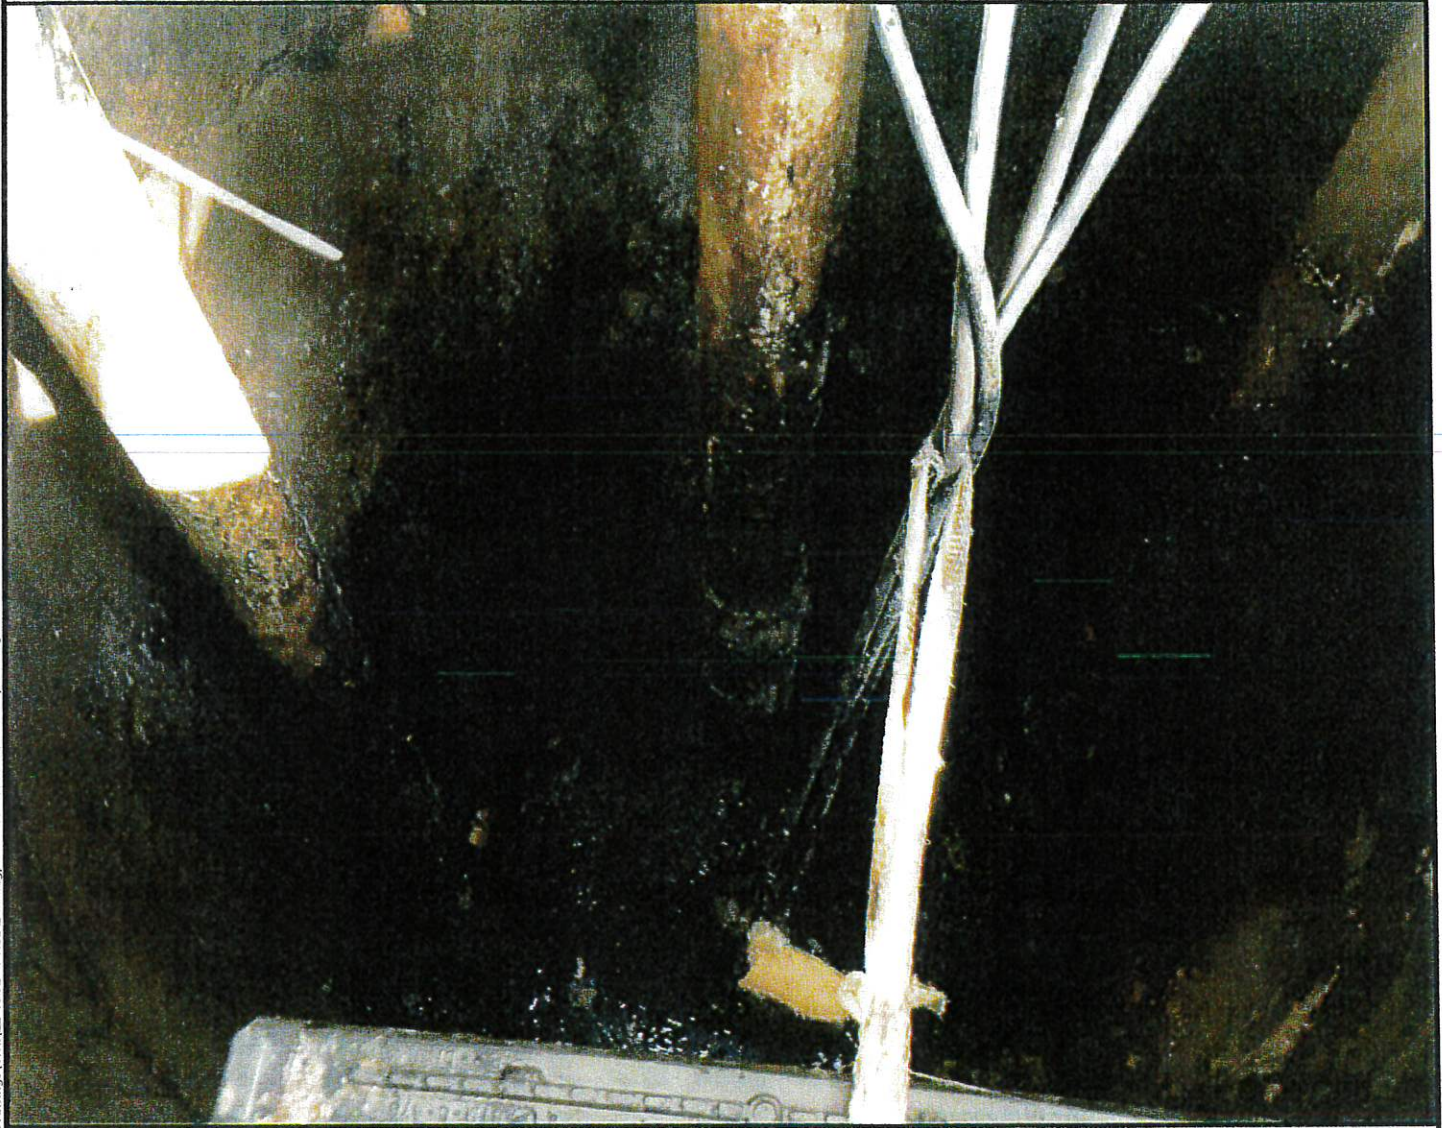
FIG 3

INSIDE OF THE  
WETWELL AT AN  
ANGLE

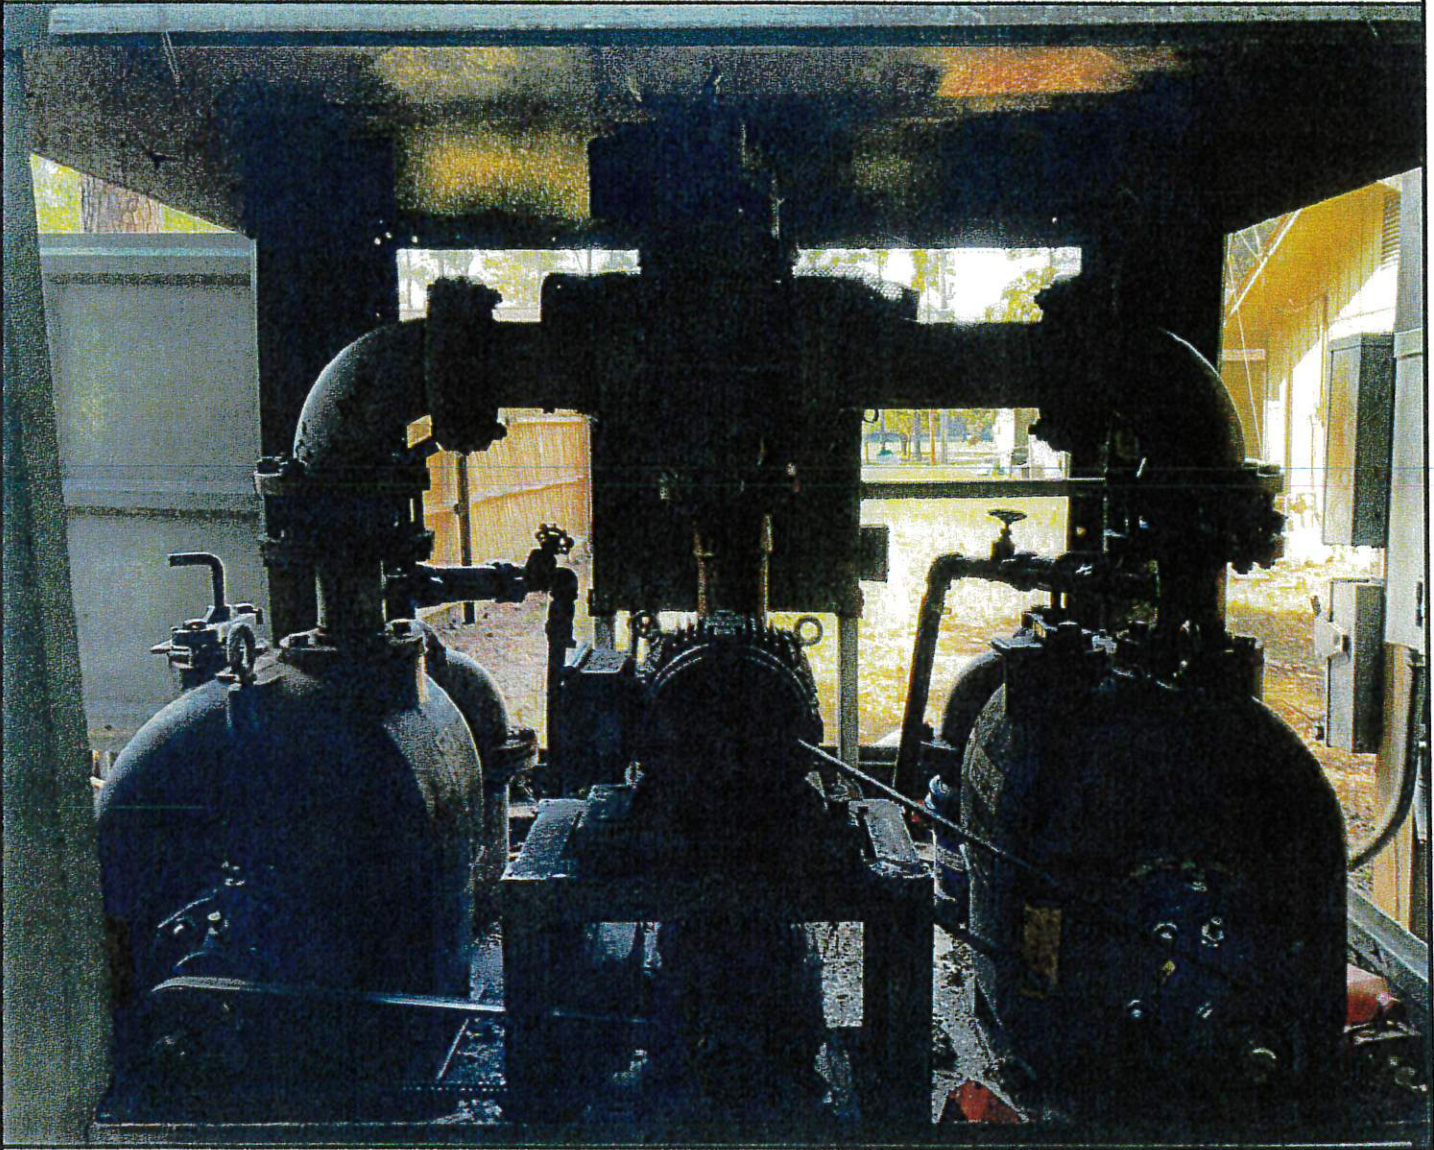
**FIG 5**

The performance of pump "A" (the right-hand pump) was first evaluated. Shown in Figure 5 are the pumps with v-belts driven by electric motors. Pump "A" was first evaluated. When the pump commenced running, the suction vacuum gauge and a discharge pressure gauge were temporarily installed. The discharge pressure gauge was measured 20 ft H<sub>2</sub>O head. The suction vacuum gauge pressure was measured 10 ft H<sub>2</sub>O with a gauge correction of 4 ft H<sub>2</sub>O. The sum of these measurements was 34 feet, which is somewhat close to the total dynamic head (TDH) of the pump at the time it was built. Subsequently, the speed of the two centrifugal pumps was determined to be 1150 rpm. The flow was determined to be approximately 117.5 gpm at 34 feet TDH using a speed of 1150 rpm and an efficiency of 35 percent. However, calculations show that the efficiency can be as high as 40 percent. This signifies that the pump might deliver up to 145 gpm based on the manufacturer's pump curve.

THE REAR VIEW OF  
THE PUMPS WITH  
V-BELTS DRIVEN BY  
ELECTRIC MOTORS.

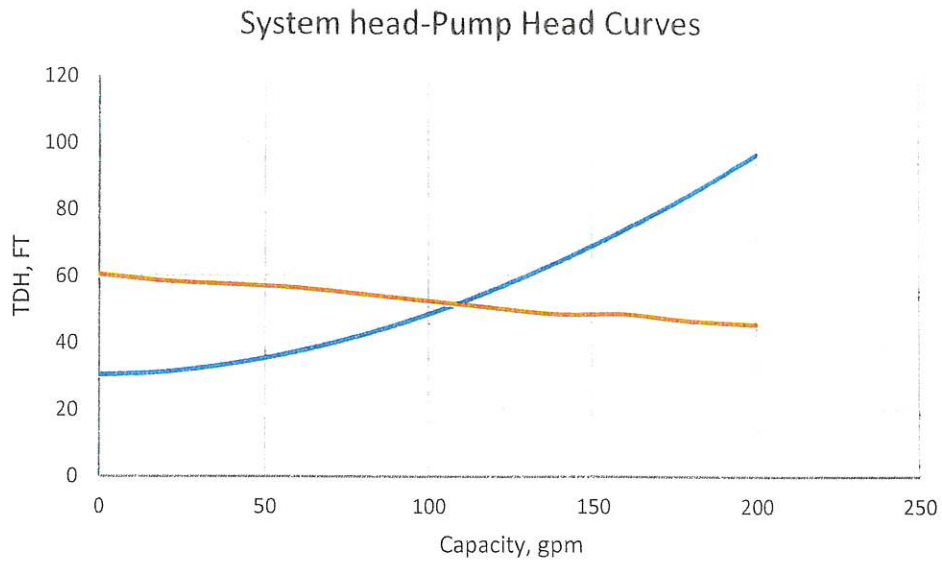
Figure 9: The System-Head and Pump-Head Curves of Bowser Pump Station.

Suction losses, station and force main frictional resistances were determined, and a system-head curve, presumably, representing the current conditions of the sewer pipe was developed. The system-head curve was developed using Hazen-Williams (HW) equation with a resistance coefficient of 120. The pump-head curve was prepared from the manufacturer's curve using a rotational speed of 1450 rpm. The intersection of the system-head and pump-head curves represents the best operating point of the pump as shown in Figure 9. The total dynamic head (TDH) was 52 feet with a discharge flow of 107.5 gpm.

It appears that the HW resistance coefficient used for the system-head curve was overly conservative based on the data obtained at the site. It follows that the utilization of HW coefficient of 130 or 140 would have better approximated the existing conditions of the piping system and pump. If a HW resistance coefficient of 130 was employed, it would have resulted in a TDH of 45 feet with a discharge of 125 gpm.
