**RESOLUTION TO ADVERTISE FOR BID TO REPLACE  
BOWSER STREET PUMP STATION**

**BOWSER ROAD PUMP STATION**

Monticello Wastewater Treatment Plant-West  
NPDES Permit Number AR0021822

**Project Number 22-5782**

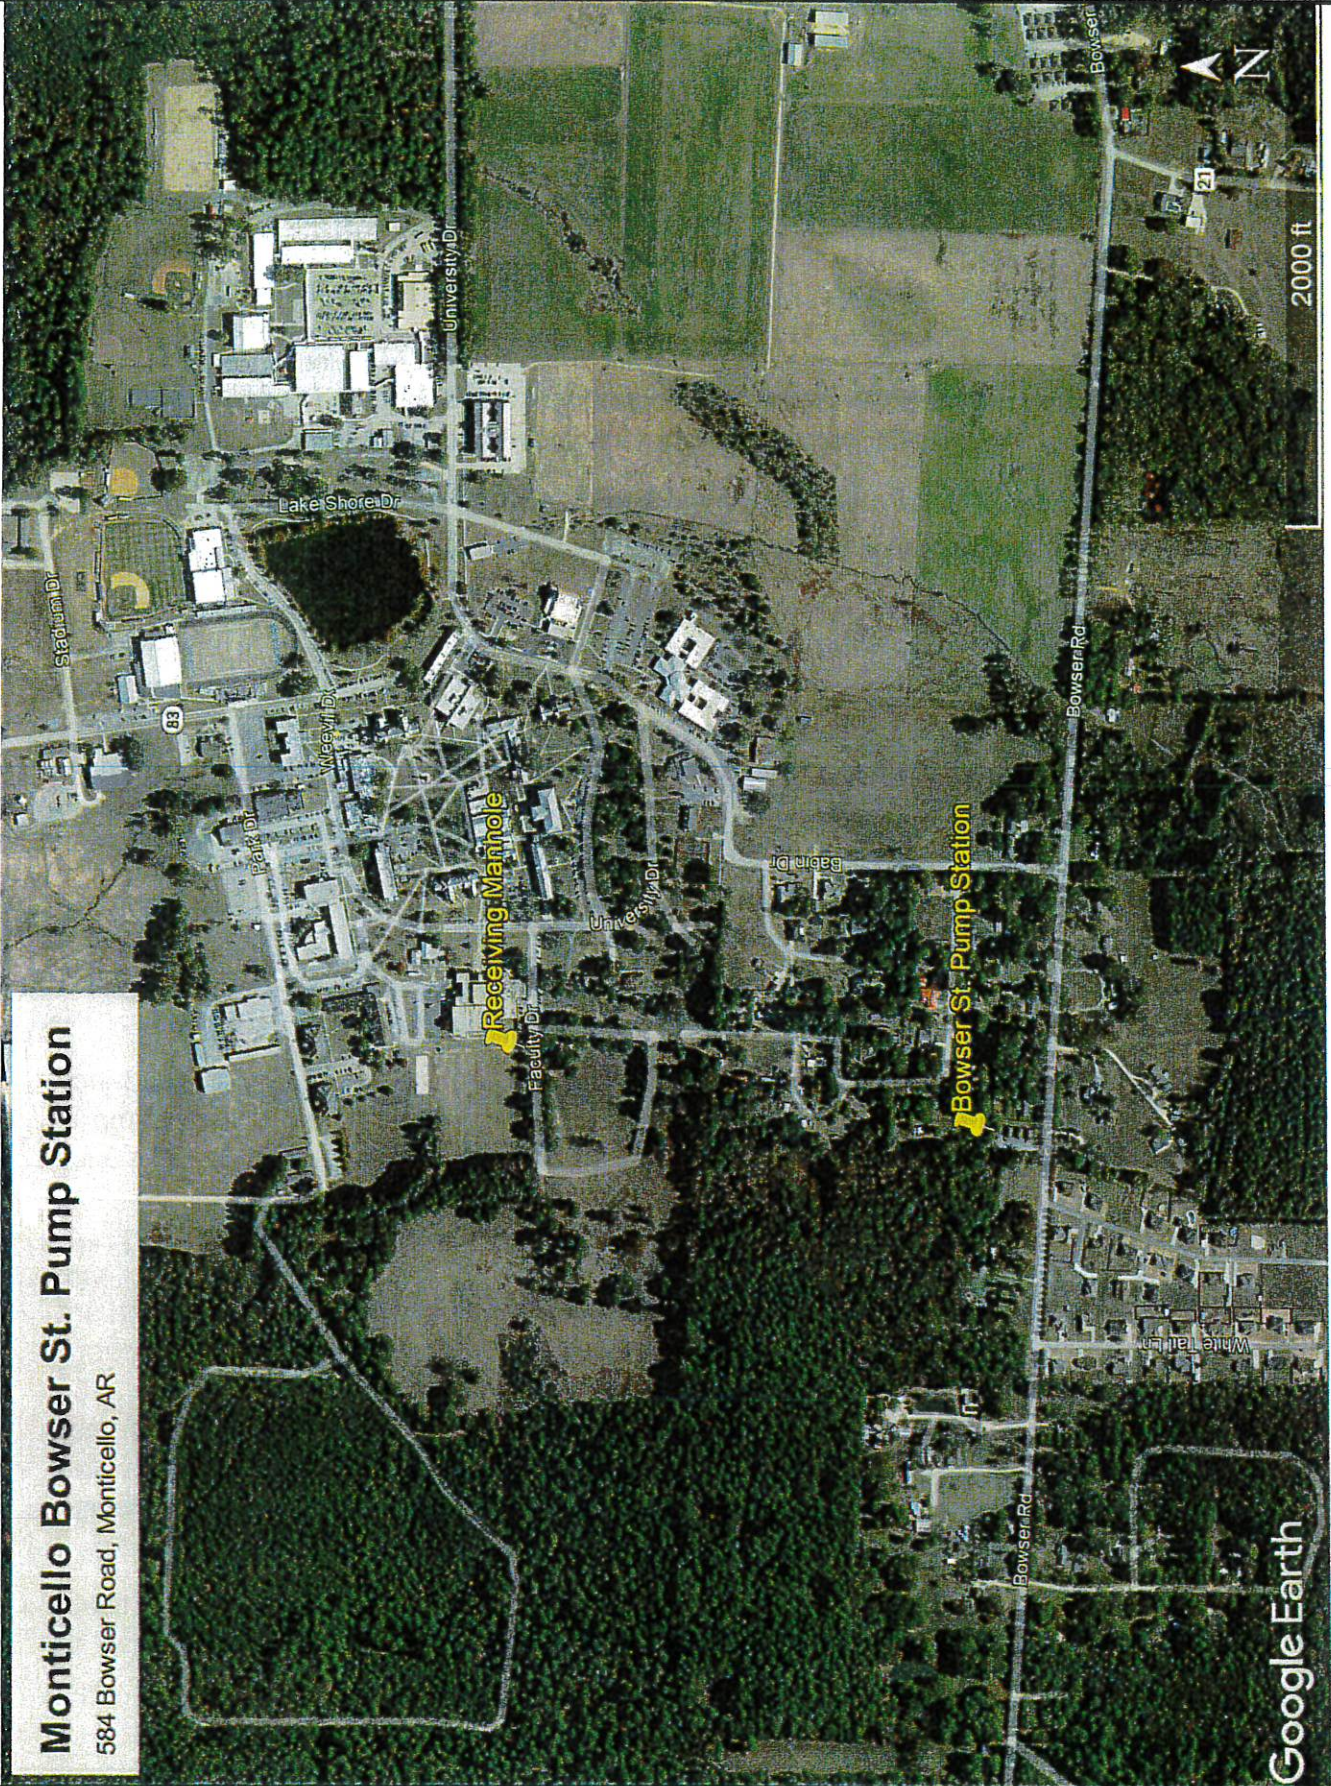
DESIGNED BY: CK	DRAWN BY: BRIN SR
DATE: 12-08-2022	REVISION:
SCALE: N.T.S.	JOB NUMBER: 22-5782
<b>FIG 1</b>

As a result, the lift station was further probed. It was then determined that the lift station was built in 1974 indicating the station is approaching 50 years old. At the time it was designed and built, the total dynamic head (TDH) was 30 ft at a capacity of 75 gallons per minute (gpm) for each pump premised on the data garnered. It appears there had been some form of modification in the past to the lift station because of the significant differences observed between the depth of the 1974 wet well and the current wet well depth, coupled with substantial changes in the site elevations. However, the time of modification and the modification type are not entirely clear due to the lack of appropriate information. The locations of the lift station and the receiving manhole are shown in Figure 1.

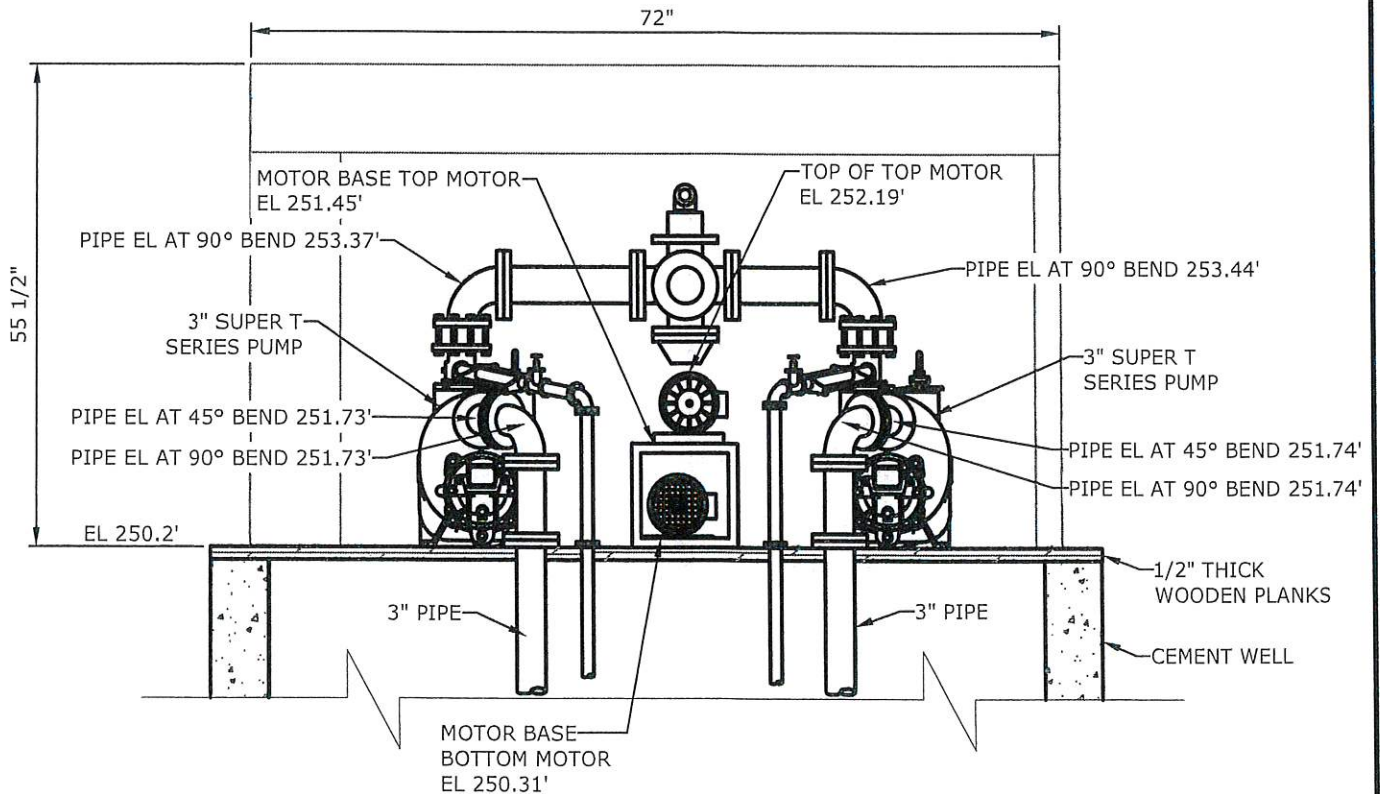
### EXISTING LIFT STATION

The lift station comprises two radial vane pumps and are surface mounted with 3-inch suction lines immersed in the raw wastewater of the wet well. This type of pump is characterized with low flows and low efficiencies. As the flow gets higher, the efficiency tends to become relatively better. The surface mounted pumps are housed in fiberglass enclosure directly above the wet well. That is, the pump equipment is completely above grade, and effectively isolated from the wet well. The pumps are operated in parallel; one pump serves as redundancy. The pumps are connected by a 3-way plug valve, and are self-priming pumps. They are 3-in pumps. Other elements of the station include check valves and elbows. Both pumps have air release lines with valves mounted independently in horizontal positions. The self-priming centrifugal pumps are manufactured by Gorman-Rupp, and are Super T Series capable of handling wastewater solids. The self-priming centrifugal pumps are v-belt looped over pulleys driven by electric motors.

The wet well is approximately a 5-foot inside diameter circular well that has floats indicating pump off and on positions. The bottom of the wet well is sloped. Figures 2 to 4 shows lift station and wet well.

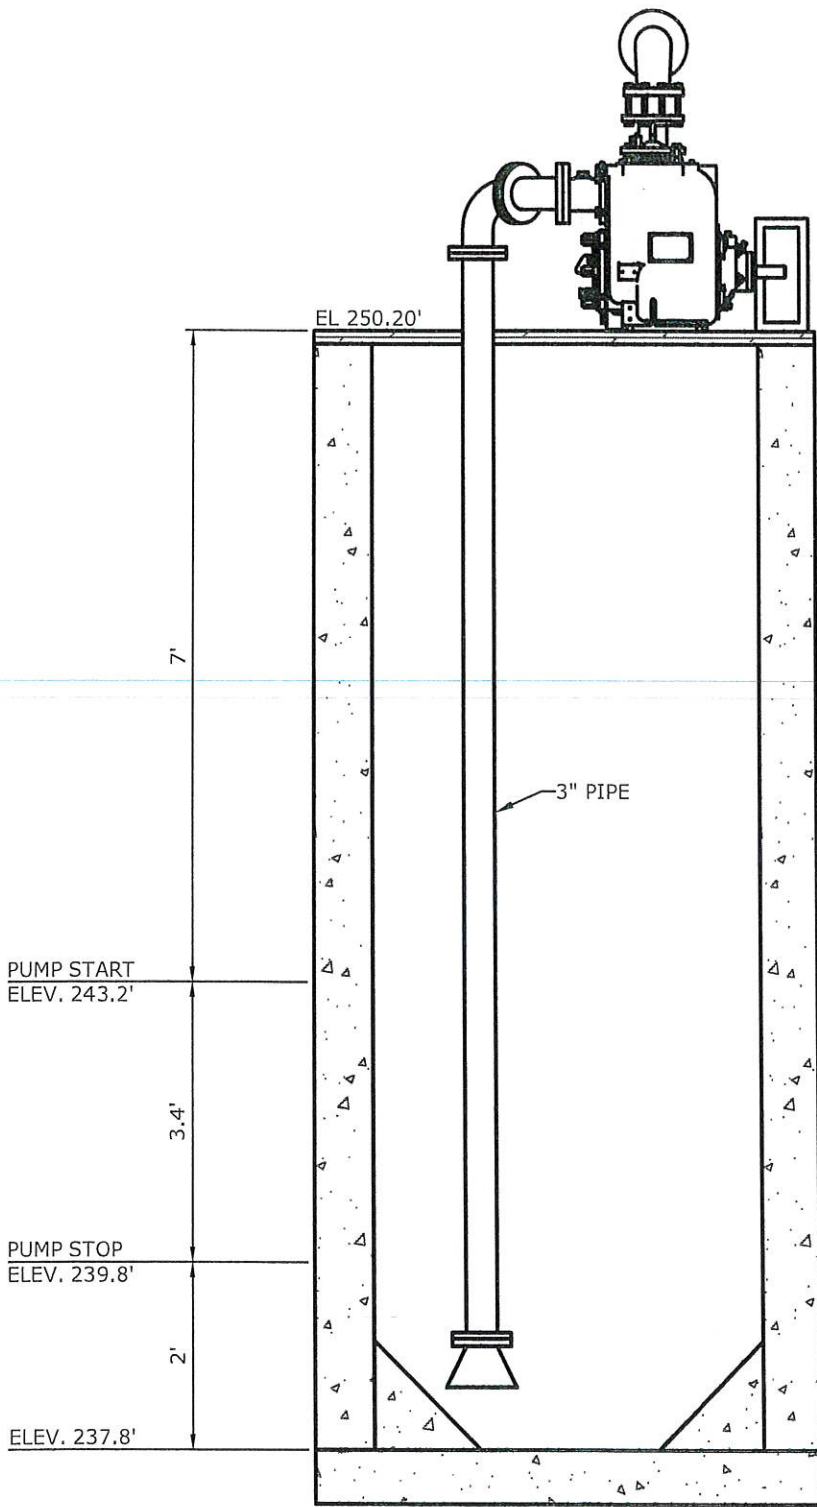
**SUPER T SERIES PUMP (RIGHT SIDE VIEW)**

The two horizontal self-priming centrifugal pumps are Super T Series manufactured by Gorman-Rupp. As shown in Figure 2 the pumps are numbered pump “A” and pump “B” with the same model no T3A3S-B. Pump “A” is at the right-hand and pump “B” is at the left-hand of Figure 2. The serial number for pump “A” is 1435305, and the serial number for pump “B” is 1617167. The size of the pump is 3” by 3” and each pump delivers 75 gpm at total dynamic head (TDH) of 30 feet.

An attempt was also made to ascertain the possibility of pump "B" to deliver raw wastewater to the force main. Pump B was running but was not priming, therefore, it was unable to deliver wastewater to the force main. No vibrations or unusual noise was noted, though it was not measured.

- A wear plate: Significant impeller clearance between the impeller and the wear plate might have contributed to the non-priming condition. Excessive clearance can

pose difficulty in creating a low-pressure area at the eye of the impeller. The large clearance could be attributed to wear and, perhaps, improper reassembly. The large clearance can be adjusted to an ideal clearance.

- Suction line blocked: One possible reason for losing priming might be an obstruction or blockage in the suction line attributable to the solids present in the influent wastewater. A blockage in the suction line can cause the water in the pump casing to overheat and literally boil out of casing making the pump to lose prime.

- Debris in the impeller: There might have been some debris in the eye of the impeller that compromised the hydraulic capabilities of the pump and impeller to create an area of low pressure. This might had prevented the pump from self-priming. Since there was no unusual noise or vibrations noted during the pumping, this might not had occurred.
